# Experimental Studies on Durability of PVD-Based CrCN/CrN-Coated Cutting Blade of Planer Knives Used in the Pine Wood Planing Process

**Keywords:** antiwear PVD-based coating; industrial planer knife; woodworking; planing process; wear; durability

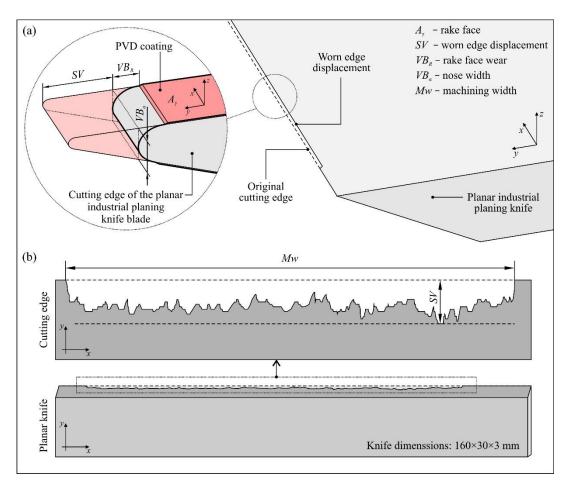
**Figure 1.** Graphical representation of (**a**) the cutting edge of the industrial planer knife blade with associated nomenclature; (**b**) basic elements of the machining width (Mw) and worn edge displacement (SV) of the cutting edge.

The tools with modified properties were mounted on cutter heads and tested under industrial conditions to determine their durability in relation to unmodified knives. Figure 1 presents graphical representation of the cutting edge of the industrial planer knife blade with PVD coating as well as basic nomenclature connected with the described issue.

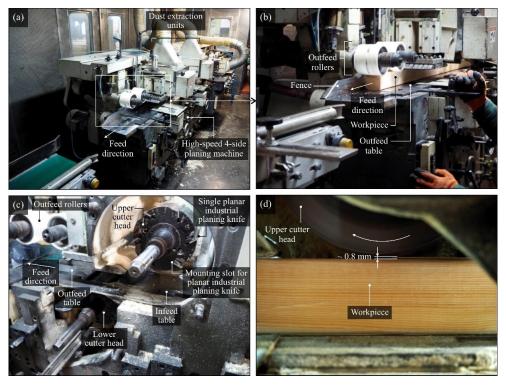
**Figure 2.** General view of (**a**) operational testing stand equipped with the high-speed four-sided planing machine Hydromat 22B, produced by Michael Weinig AG, during processing of the pine wood (Scots pine (*Pinus sylvestris* L.)); (**b**) calibration process on the first few elements of the production batch; (**c**) two cutter heads during assembly; (**d**) machining zone of the upper cutter head (U1) with visible machining allowance (in this case, ~0.8 mm), which was removed by the last set of industrial planer knives mounted on this head.

The planing process was carried out on a piece of wet pine (Scots pine (*Pinus sylvestris* L.) with 35–55% humidity) at feed speed of 57 m/min at a spindle speed of 6000 rpm. The total machining allowance was 5 mm, and it was removed for the most part by the first set of cutter heads in the roughing range. The tested knives were mounted on the second (last) set of heads, and the allowance for this operation was approximately 0.8 mm. In Figure 2, the operational testing stand equipped with the high-speed four-sided planing machine Hydromat 22B, produced by Michael Weinig AG (Tauberbischofsheim, Germany), is presented.

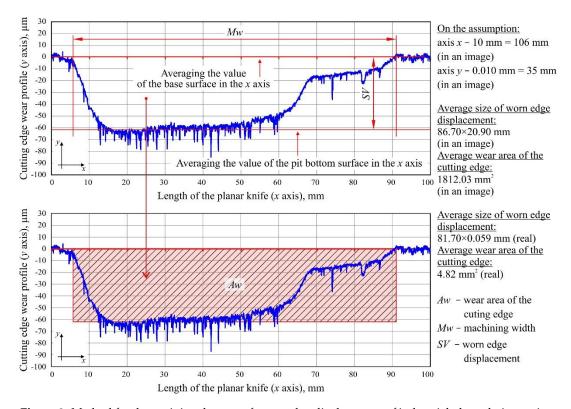
**Figure 3.** Method for determining the area of worn edge displacement of industrial planer knives using the example of a fragment of the surface profile  $(100 \times 0.130 \text{ mm})$  of knife No. 9 (Set 1, Head U1).

The measurements were carried out using of a stylus profilometer (Hommel Tester T8000; Hommelwerke GmbH, Villingen-Schwenningen, Germany), which was more widely presented in the works of Kałonek et al. [29,30]. The instrument was equipped with a TKU-100 pick-up with a diamond stylus tip (opening angle:  $90^{\circ}$ , tip radius:  $1.5 \, \mu m$ ). The pick-up was part of a traverse unit (Waveline<sup>TM</sup> 60 Basic; tracing length:  $60 \, mm$ , resolution:  $0.1 \, \mu m$ , tracing speed: 0.1–3 mm/s) mounted on a measuring column (Wavelift<sup>TM</sup> 400M; maximum traverse:  $400 \, mm$ ). The column was, in turn, mounted on a granite plate (Wavesystem<sup>TM</sup> 780; dimensions:  $780 \times 500 \times 100 \, mm$ ). On the plate, a small angle vise was placed, and the industrial planer knife prepared for measurements was mounted on the clamps. To set the conditions and carry out measurements with the stylus profilometer, a Turbo Roughness 3.1 software (Hommelwerke GmbH, Villingen-Schwenningen, Germany) provided by the manufacturer of the instrument was used. The method for determining the area of worn edge displacement and the radius of the cutting edge of the planar industrial planer knives is presented in Figures 3 and 4, respectively.

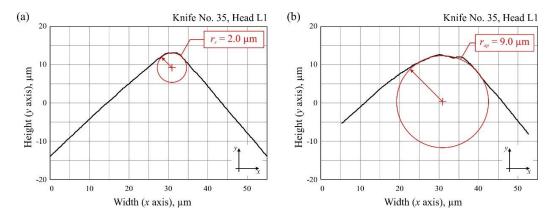
**Figure 4.** Method for determining the radius of the cutting edge of the industrial planer knives: (a) No. 35 (reference) (Set 1, Head L1); (b) No. 35 (after processing) (Set 1, Head L1).

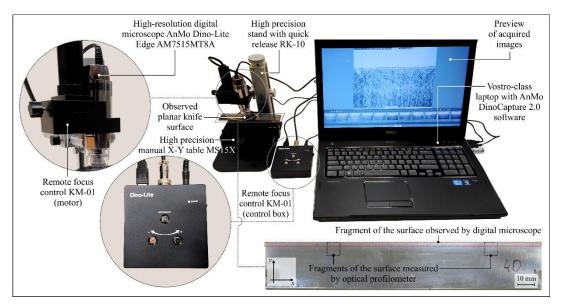
**Figure 5.** General view of the setup used for acquisition of digital images of selected fragments of the rake face of industrial planer knives based on the high-resolution digital microscope Dino-Lite Edge AM7515MT8A, produced by AnMo Electronics Corp.

The microscopic observations were carried out on a specially prepared setup, as shown in Figure 5. The main element of the setup was the high-resolution digital microscope AnMo Dino-Lite Edge

AM7515MT8A, produced by AnMo Electronics Corp. (New Taipei City, Taiwan), equipped with a matrix complementary metal-oxide semiconductor (CMOS) detector providing 5 megapixel (2592 × 1944 pixel) resolution, which allowed observation of the surface of the industrial planer knives at magnification in the range of 700–900× as well as recording of a video sequence (30 fps). The microscope was powered via a signal cable connected to the USB port of a Vostro laptop produced by Dell Inc. (Round Rock, TX, USA). As a light source, a set of eight integrated light-emitting diodes (LEDs) characterized by the function of flexible control of illumination intensity (flexible LED control, FLC) was used. It allowed switching between brightfield and coaxial illuminations or combining them. Coaxial illumination technology is particularly beneficial because it reveals details that are difficult to observe under typical conditions. The instrument had an automatic magnification reading (AMR) function, which automatically detected the magnification and displayed it in the DinoCapture 2.0 software.

The image acquisition of the industrial planer knives was carried out for a selected fragment of the rake face before the machining process (as a reference) and a fragment of the rake face after the machining process with visible wear. The range of magnification was  $690 \times to 700 \times (FOV 0.533 \times 0.408 \text{ mm})$ . All images were acquired in high resolution (2592  $\times$  1944 pixels) and saved as \*.TIF files.

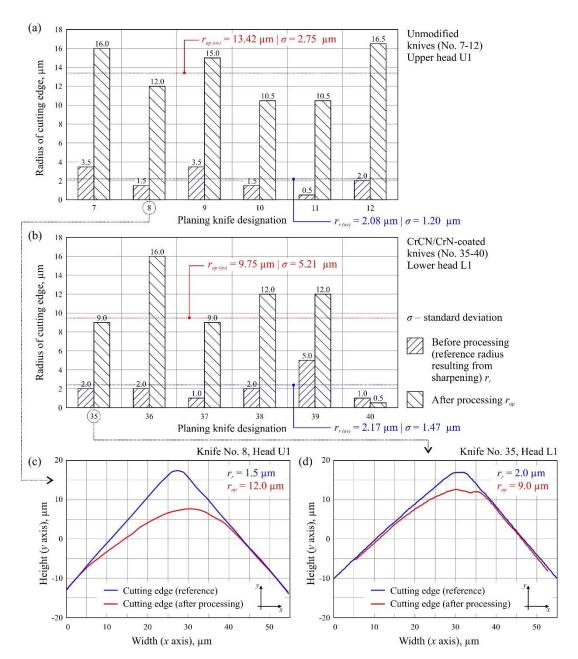
**Figure 7.** Measurement of the radius of the cutting edge of planer knives for (a) unmodified knives No. 7–12 and (b) CrCN/CrN-coated knives No. 35–40. Examples of specific values of the radius for (c) knife No. 8 (Set 1, Head U1) and (d) knife No. 35 (Set 1, Head L1).

Figure 7a,b presents a summary of the radius of the cutting edge in and out of the working area for all 12 analyzed knives as well as their mean values. Additionally, the wear of selected blade radii is presented in Figure 7c,d.

Analysis of the measured radii of planer knife blades indicated their significant differences, evaluated in relation to the reference radius (after sharpening) and the radius measured after the planing process. These differences ranged from  $7 \times$  to  $21 \times$  for unmodified knives and from  $2 \times$  to  $9 \times$  for CrCN/CrN-coated knives, with the radius increasing as a result of intensified blade wear. The average value of the radius of the cutting edge after sharpening was similar for both groups of tools under consideration, i.e.,  $r_{r(av)} = 2.08 \,\mu\text{m}$  for unmodified knives and  $r_{r(av)} = 2.17 \,\mu\text{m}$  for CrCN/CrN-coated knives. Comparison of the average value of the radius of the cutting edge after processing for modified ( $r_{ap(av)} = 9.75 \,\mu\text{m}$ ) and unmodified knives ( $r_{ap(av)} = 13.42 \,\mu\text{m}$ ) at the end of their lives indicated a beneficial effect of CrCN/CrN coating.

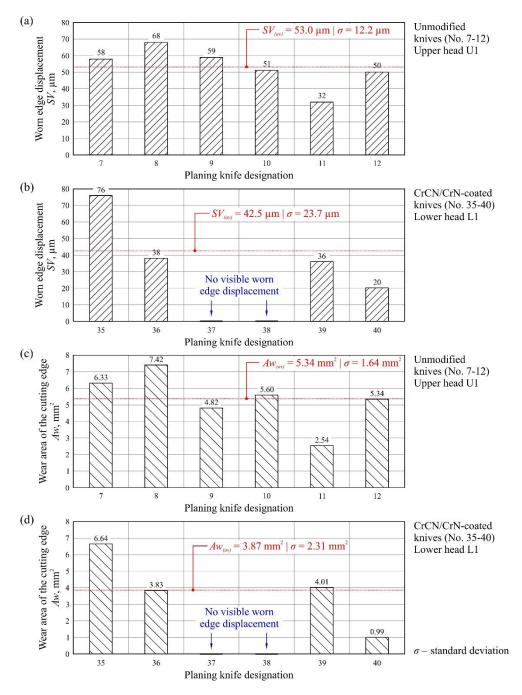
**Figure 8.** Measurement of the worn edge displacement (*SV*) of planer knives for (**a**) unmodified knives No. 7–12 and (**b**) CrCN/CrN-coated knives No. 35–40. Examples of specific values of wear area of the cutting edge for (**c**) unmodified knives No. 7–12 and (**d**) CrCN/CrN-coated knives No. 35–40.

In the next stage, the worn edge displacement (SV) as well as wear area of the cutting edge (Aw) were designated for unmodified and CrCN/CrN-coated knives. These measurements are shown in Figure 8, together with the average values of the parameters ( $SV_{(av)}$  and  $Aw_{(av)}$ ) specified for each set of knives.

The measured values of worn edge displacement had comparable values for both modified (SV = 20–76 µm) and unmodified (SV = 32–68 µm) knives (Figure 8a,b). The values that were determined differed in relation to individual knives on a given cutter head by up to four times, e.g., SV = 20 µm for knife No. 40 and SV = 76 µm for knife No. 35 (Head L1, Figure 8b). Additionally, no clear worn edge displacement was identified for knives No. 37–38. For the wear area of the cutting edge directly from

the measurement of *SV* and for the determined values (Figure 8c,d), similar dispersion was observed as that for the worn edge displacement.

The observed dispersion of the values of worn edge displacement and wear area between individual knives on a given cutter head was largely the result of differences in positioning of individual blades on the head as well as the varying degree of their deformation after removal, such as that caused by relaxation of stresses introduced into the structure of the tool due to the effect of heat in the planing process. The obtained results also indicated smaller values of both the parameters (SV and Aw) on the cutter head with mounted CrCN/CrN-coated knives. This could be clearly seen by

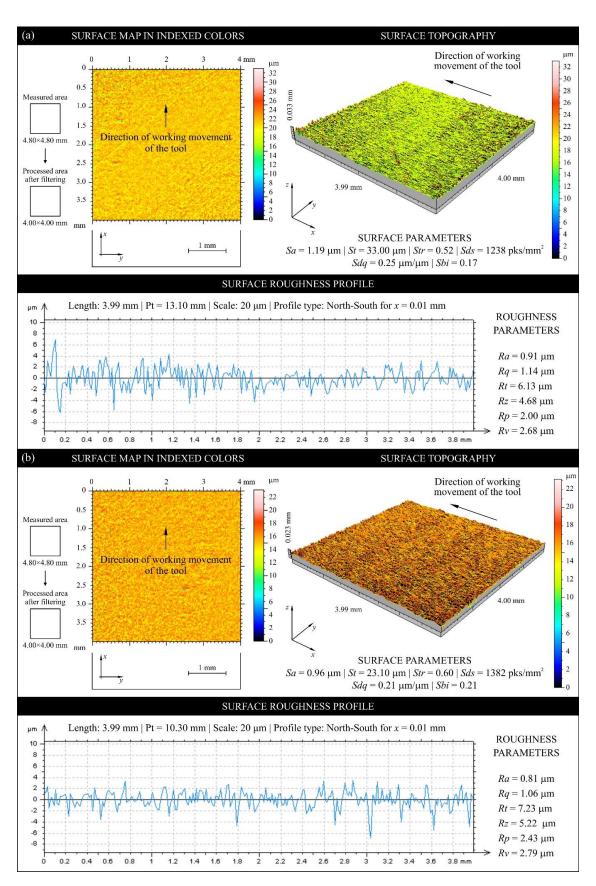
**Figure 9.** Collection of measurements obtained using an optical profilometer (Talysurf CLI 2000) for the rake face of unmodified industrial planer knife No. 9 (Set 1, Head U1) (**a**) before processing (reference) and (**b**) after processing.

Figure 9 shows sample texture measurements of the rake face of the unmodified industrial planer knife (knife No. 9, Head U1) in unused and worn zone, while Figure 10 shows the same compression results for the tool modified with PVD coating (knife No. 35, Head L1). Figures 11 and 12 show diagrams comparing the values of all analyzed texture parameters of the surface in the worn zone and, as a reference, the values determined in the part of the edge that did not take part in the planing process for all knives from U1 (No. 7–12) and L1 (No. 35–40) heads.

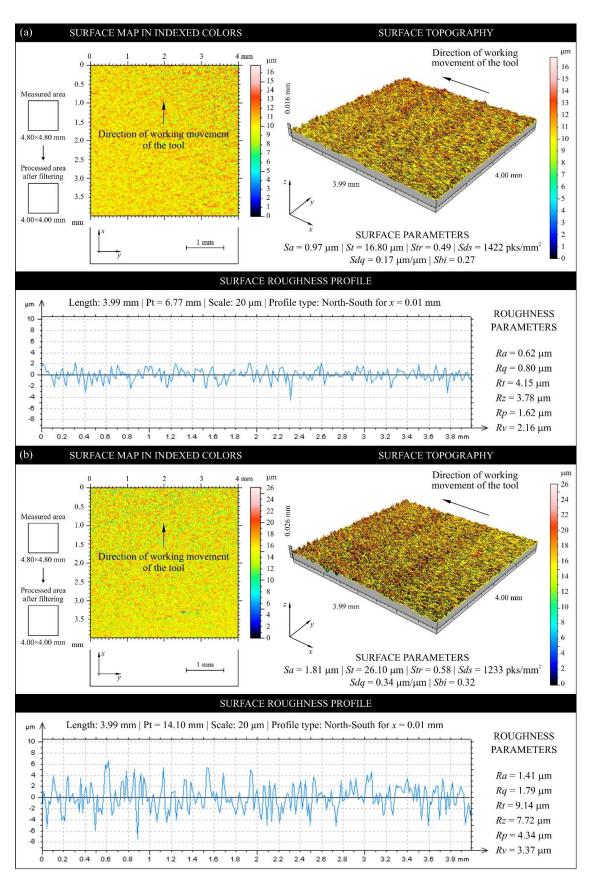
**Figure 10.** Collection of measurements obtained using an optical profilometer (Talysurf CLI 2000) for the rake face of CrCN/CrN-coated industrial planer knife No. 35 (Set 1, Head L1) (a) before processing (reference) and (b) after processing.

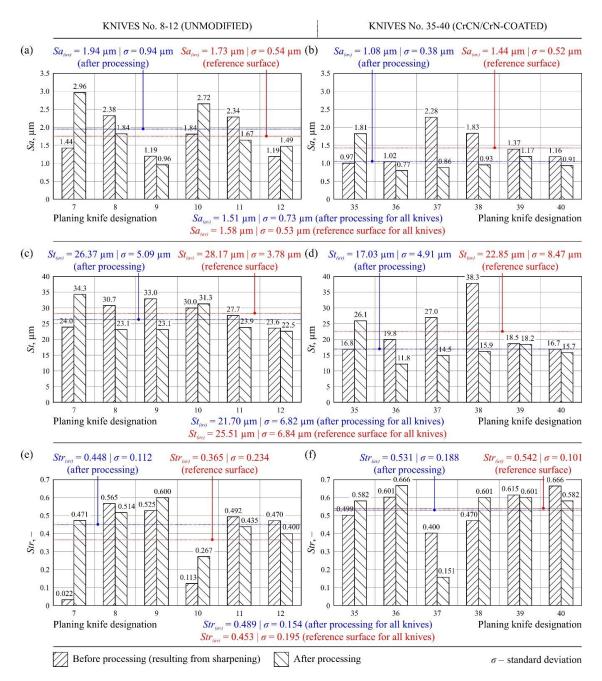
**Figure 11.** Values of texture parameters of the rake faces of (**a**,**c**,**e**) unmodified knives No. 7–12 and (**b**,**d**,**f**) CrCN/CrN-coated knives No. 35–40: (**a**,**b**) arithmetic mean deviation of the surface (*Sa*); (**c**,**d**) total height of the surface (*St*); (**e**,**f**) texture aspect ratio of the surface (*Str*).

The Sa parameter, defined as the arithmetic mean deviation of the surface, is the basic amplitude parameter used in the spatial evaluation of machined surface texture. The average value of this parameter for all analyzed knives in the reference zone was  $Sa_{(av)}=1.58~\mu m$ , while it was  $Sa_{(av)}=1.51~\mu m$  in the zone after processing (Figure 11a,b). For most of the analyzed knives, a decrease in this parameter was recorded on the surfaces after work. The lower value of Sa in the zone after work was largely determined by abrasive wear. It caused smoothing of the vertices of the rake face, which had formed an uneven shape during the knife manufacturing process. The measurements also showed that the average values of Sa were significantly lower in the case of CrCN/CrN-coated knives, showing the influence of PVD coating on the measured surface roughness of the knives.

The texture aspect ratio of the surface (Str) can be used to determine the machining traces in any direction of the analyzed surface. The average values of this basic spatial parameter for both zones under consideration of all the analyzed tools were  $Str_{(av)} = 0.489 \, \mu m$  (zone after processing) and  $Str_{(av)} = 0.453 \, \mu m$  (reference zone), as shown in Figure 11e,f. In addition, significant variability was clearly visible in the values of this parameter for individual knives. On the basis of the Str values obtained, it can be concluded that there was no change in the direction of the machining marks on the surface of the analyzed knives as a result of machining.

The second additional spatial parameter applied was Sds, describing the density of the surface summits (number of summits per unit area, given in mm<sup>2</sup> in this case). Its average values for both zones under consideration of all the analyzed tools were  $Sds_{(av)} = 1302.5$  pks/mm<sup>2</sup> (zone after processing) and  $Sds_{(av)} = 1245.2$  pks/mm<sup>2</sup> (reference zone), as shown in Figure 12a,b. The values showed no significant differences in density of surface summits, both between modified and unmodified knives as well as changes resulting from knife wear.

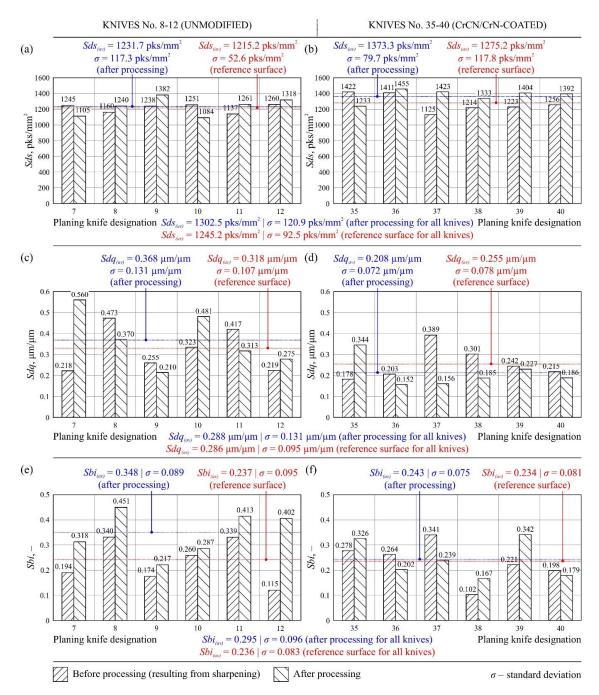
**Figure 12.** Values of texture parameters of the rake faces of (**a**,**c**,**e**) unmodified knives No. 7–12 and (**b**,**d**,**f**) CrCN/CrN-coated knives No. 35–40: (**a**,**b**) density of summits of the surface (*Sds*); (**c**,**d**) root-mean-square slope of the surface (*Sdq*); (**e**,**f**) surface bearing index (*Sbi*).

The additional hybrid parameter, Sdq, defined as the root-mean-square slope of the surface, was used to measure the slopes that constitute the surface and could be useful in identifying surfaces with similar average unevenness. With few exceptions, the values of Sdq decreased as a result of knife operation (Figure 12c,d). However, the mean values of the slope of the surface for both zones of all the analyzed tools were very similar, i.e.,  $Sdq_{(av)} = 0.288 \, \mu\text{m}/\mu\text{m}$  (zone after processing) and  $Sdq_{(av)} = 0.286 \, \mu\text{m}/\mu\text{m}$  (reference zone), as shown in Figure 12c,d. Comparison of mean values for the group of unmodified and CrCN/CrN-coated knives showed about 30% reduction of Sdq for modified knives, which might have been a result of PVD coating.

The functional Sbi (surface bearing index) parameter of auxiliary nature contained the following average values for all analyzed tools:  $Sbi_{(av)} = 0.295$  (zone after processing) and  $Sbi_{(av)} = 0.236$  (reference zone), as shown in Figure 12e,f. The parameter Sbi refers to the surface load capacity, and it can be concluded that the application of CrCN/CrN antiwear coating did not significantly affect this aspect of surface texture evaluation for the analyzed rake faces of planer knives. However, an unambiguous evaluation of Sbi was difficult due to significant dispersion of the determined surface bearing index values (Figure 12e,f).

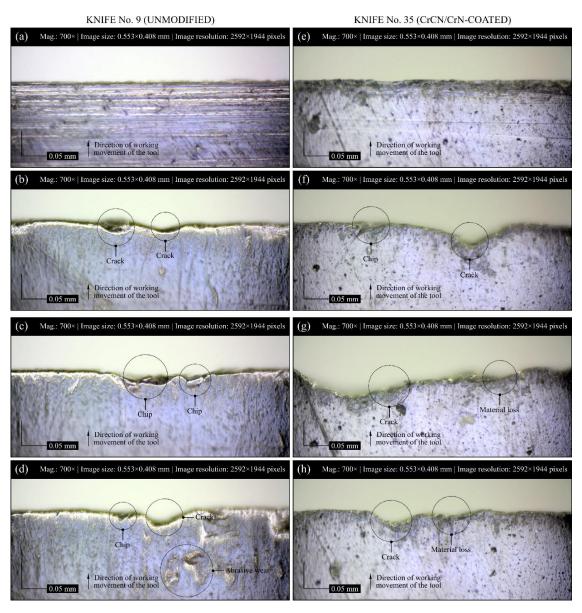
**Figure 13.** Selected results of digital images acquired of the rake face of industrial planer knives: (a) surface of unmodified knife No. 9 (Set 1, Head U1) (reference), (b–d) with various visible forms of surface wear; (e) modified knife No. 35 (Set 1, Head L1) (reference), (f–h) with visible wear of the surface.

In addition to measurements with the stylus profilometer (Hommel-Teser T8000 from Hommelwerke) and optical multiprophilometer (Taylor-Hobson CLI 2000) of cutting edge radius in and out of the working area, microscopic observations and acquisition of digital images of the cutting edge in the pre- and postmachining conditions were also carried out to analyze the worn edge displacement of industrial planer knives and their geometric texture. Selected results of the acquisition process for modified knife No. 35 (Set 1, Head L1) and unmodified knife No. 9 (Set 1, Head U1) are presented in Figures 13a–d and 13e–h, respectively. Additionally, the form of wear and the level of wear intensity occurring on the rake face of all the analyzed industrial planer knives are presented in Table 4.

Observations of the tool surfaces, regardless of whether or not they concerned modified or unmodified knives, revealed numerous differences, resulting mainly from various forms of wear and their different intensities. Microscopic observations provided the basis for qualitative evaluation of the cutting edge after work, and they showed a limited number of wear forms and lower intensity of wear on CrCN/CrN-coated knives compared to unmodified knives (Table 4). The rake face of the unmodified knives was highly dominated by abrasive wear, cracks, and chips, with a slight share of the initial lapping, while chips were the main form of wear observed on the rake face of CrCN/CrN-coated knives. On these knives, abrasive wear and cracks were occurring at a slightly lesser extent, with a total lack of wear arising from the initial lapping. A small number of wear forms and low intensity of wear correlated with the relatively lower values of the surface texture parameters measured using the optical profilometer for CrCN/CrN-coated knives (Figures 11 and 12). This confirmed the beneficial effect of the implemented tool modification. The PVD coating made it possible to significantly reduce the intensity of the wear process. When evaluating results of the observation, it should be noted that the modified knives worked much longer (142% increase in durability) than the unmodified ones.
